BEFORE
THE PUBLIC SERVICE COMMISSION OF
SOUTH CAROLINA

DOCKET NO. 2012-177-WS

IN RE: Application of Tega Cay Water)
 Service, Inc. for adjustment of)
 rates and charges and modifications)
 to certain terms and conditions)
 for the provision of water and sewer)
 service)

TESTIMONY OF MAC MITCHELL

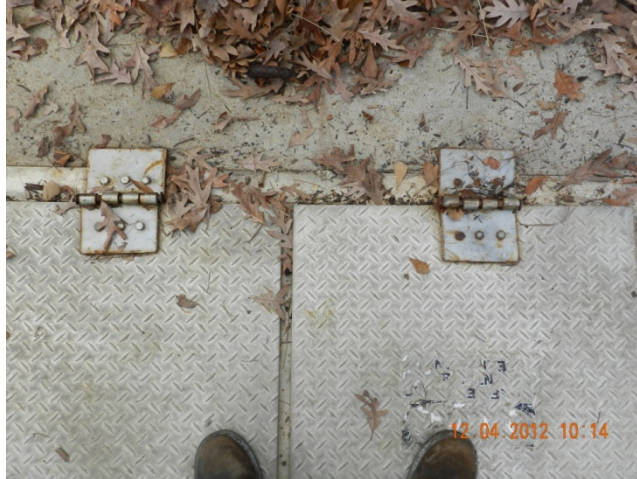
Exhibit MM 1

17 **A.** Yes. Lift Station No. 1 is located at 1077 Gauguin Lane. Mr. Kunzman testified that a
18 hinge pin was missing on a well lid was missing. However, TCWS's inspection on December 4,
19 2012, did not show the pin missing. Below, is a picture (Exhibit MM1) taken by TCWS Area
20 Manager Mike Davis showing the lid with functioning hinges.

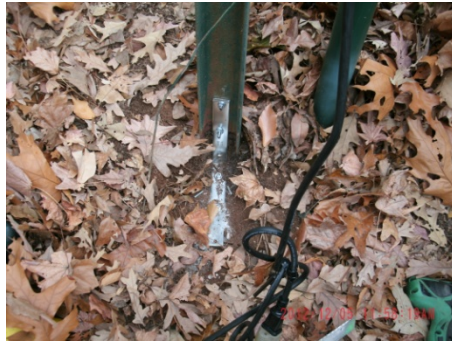
3
4 Exhibit MM4

19 A. Yes, at Lift Station No. 5, which is located at 7001 Tega Cay Dr., Mr. Kunzman was
20 concerned that the support legs on the stand for the electric meter and breaker box were rusted.
21 TCWS personnel visited Lift Station No. 5 on December 4, 2012, and the stand was upright.

1 However, as illustrated in Exhibits MM4 and MM5, the stand has since been braced to ensure its
2 continued stability.
